**U.S. Playing Card Company
Beech Street Facility**

PHASE I ENVIRONMENTAL SITE ASSESSMENT

United States Playing Card facility roofing review

PHOTO LOG: USPC Property Inspection—Norwood, Ohio
April 26, 2004

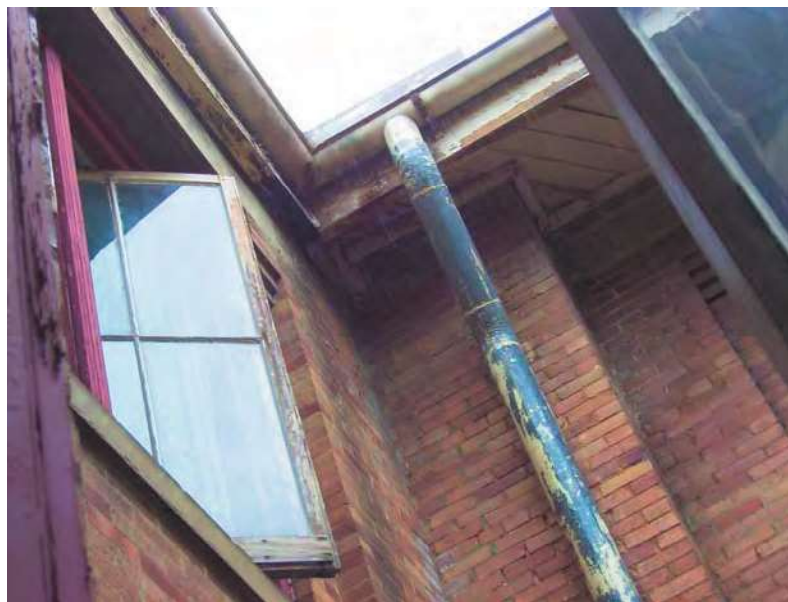
Building 03—Photo #18: Window at junction of Building 02, tuck point masonry. Water damaged gutter boards.

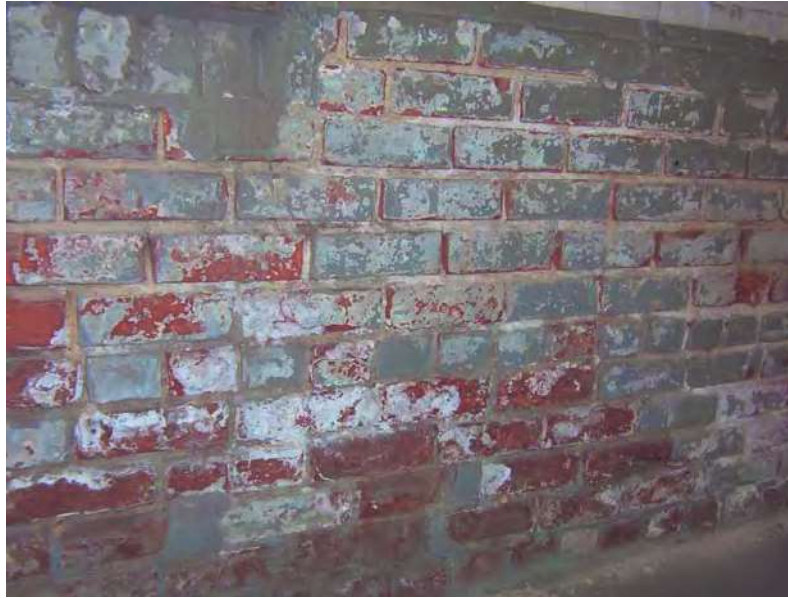
Building 03—Photo #19; North inside wall interior. Deteriorating mortar joints.

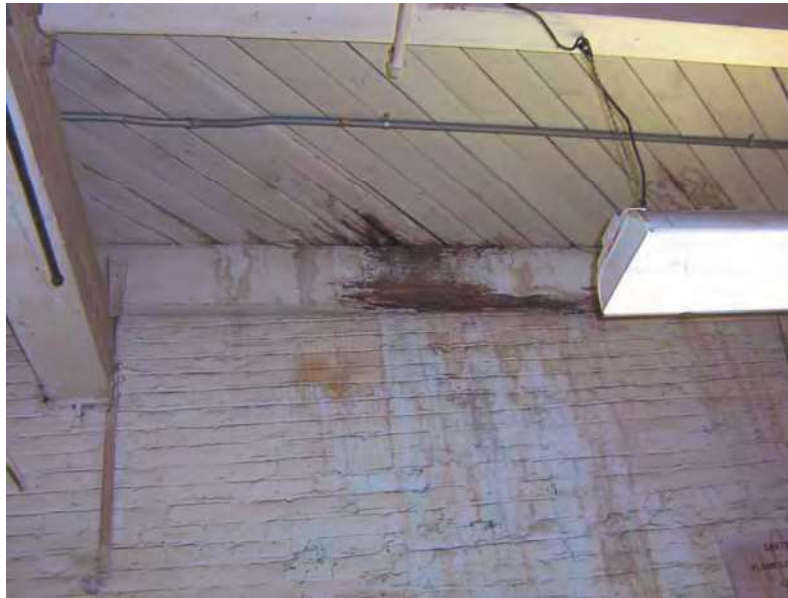
Building 03—Photo #20: Roof deck, roof leak and damaged wood beam.

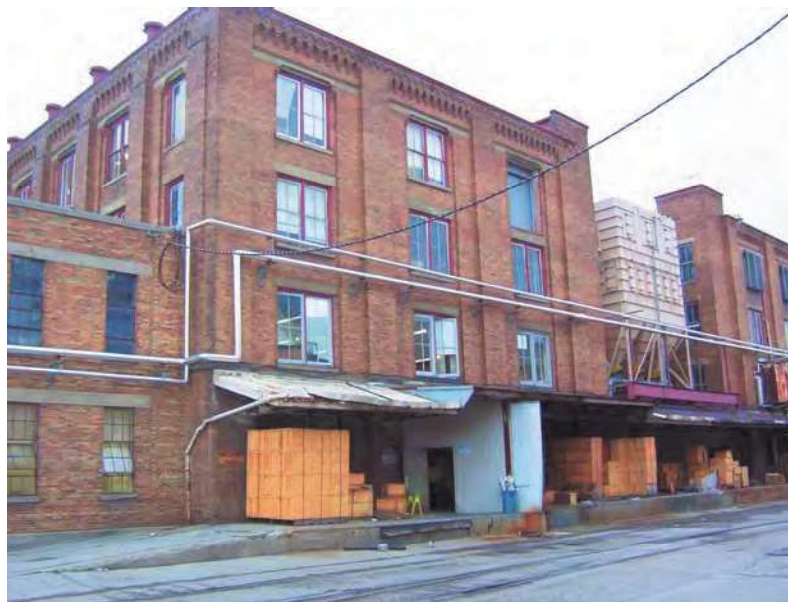
Building 04—Photo #23: East Elevation, damaged awning.

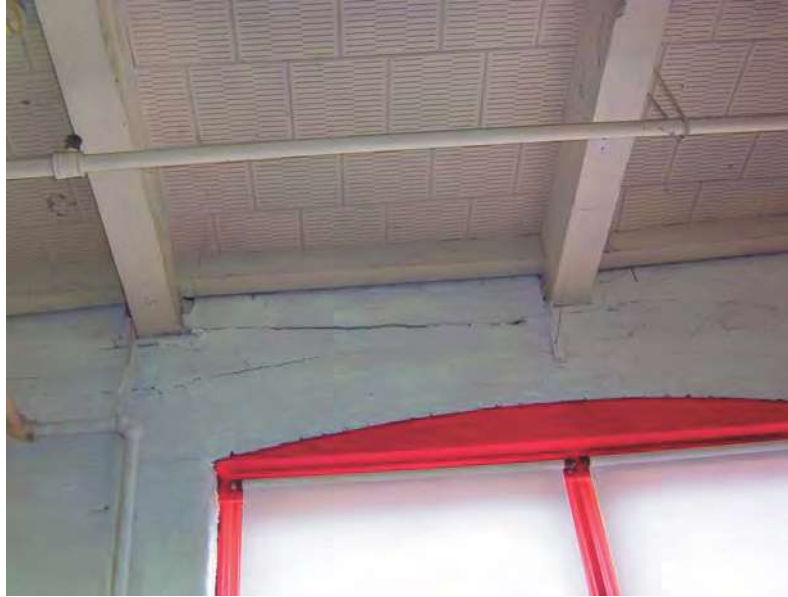
Building 04—Photo #26: Fourth floor. Crack in masonry above window.

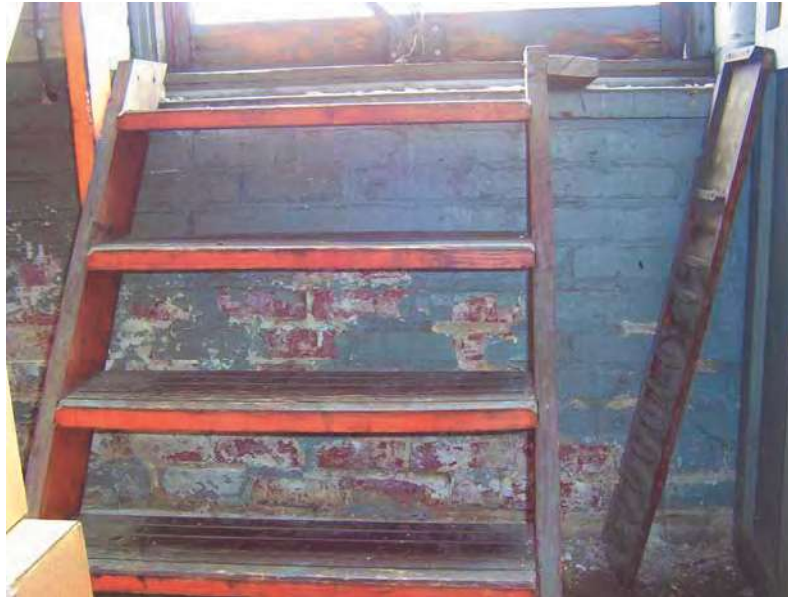
Building 04—Photo #28: Southeast corner, water damaged masonry under window access to roof.

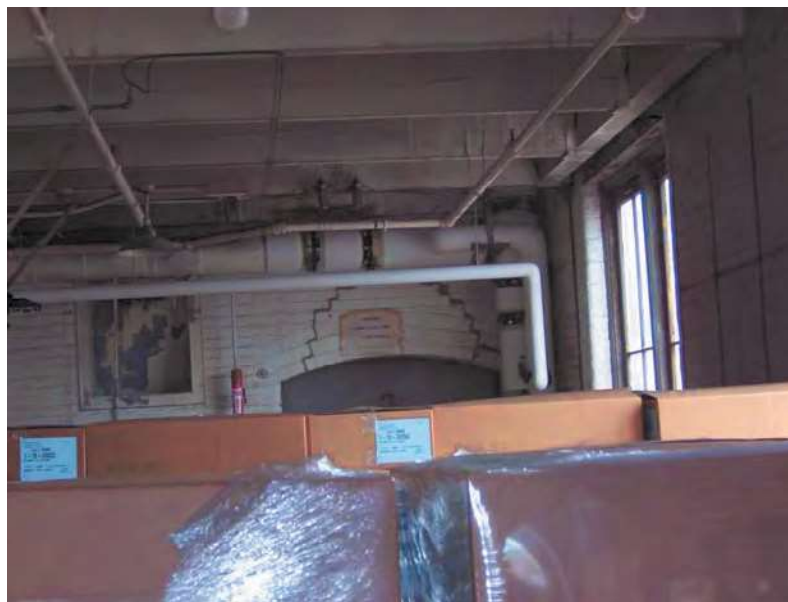
Building 04—Photo @29: Third floor, damaged masonry at arched door head.

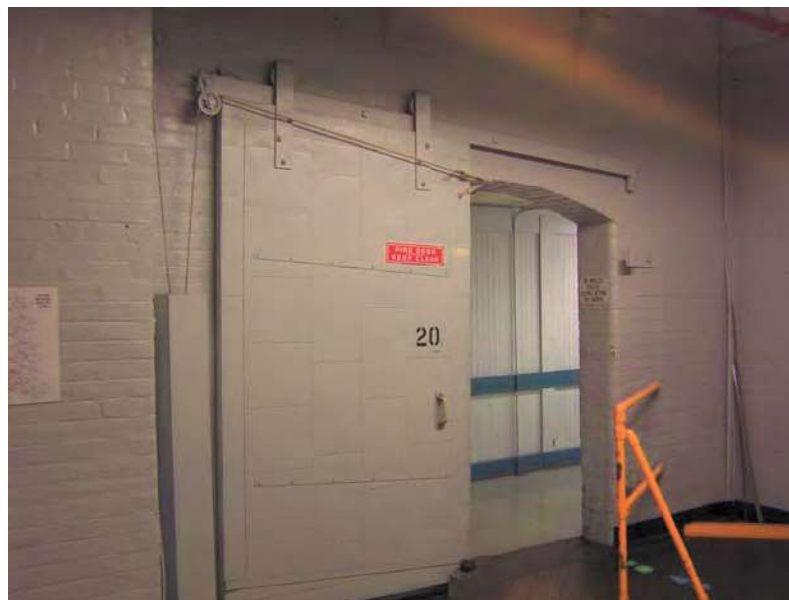
Building 04—Photo #31: Typical fire door found throughout facility. Current Building Code Standards no longer allows this type of door.

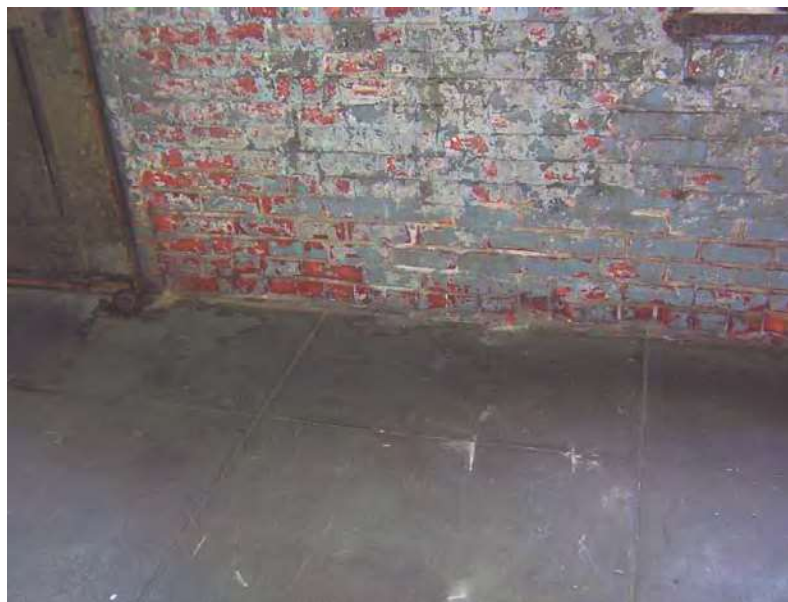
Building 04—Photo #33: Ground floor. Deteriorated mortar joints in masonry wall, under windows.

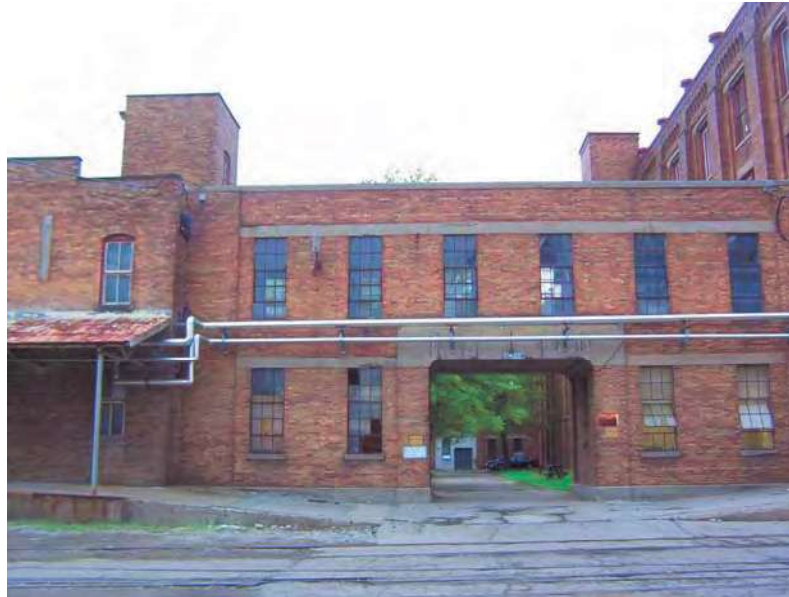
Building 06 (Left) and Building 04 (Right) - Photo #40; Connector East Elevation, Exposed concrete beam, exposed reinforcing steel.

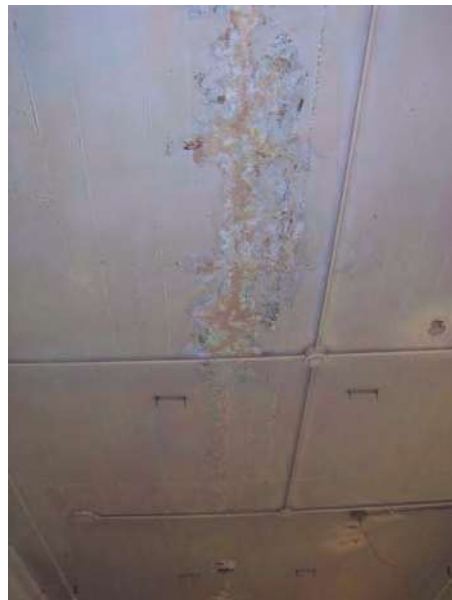
Building 06A—Photo #45: Connector. Roof deck indicating water damage.

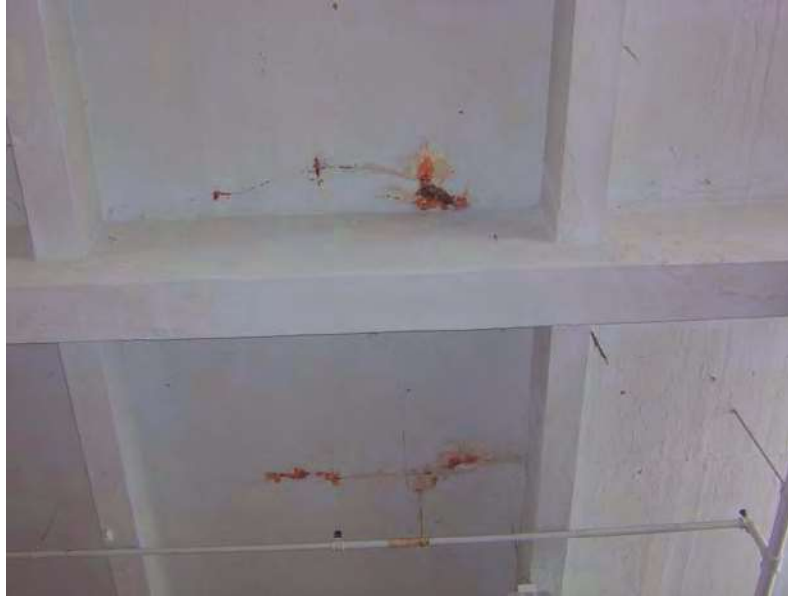
Building 07—Photo #60: Water damaged roof deck at clerestory roof.

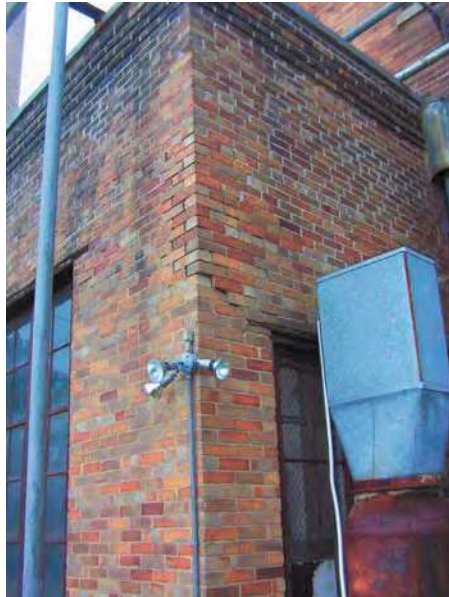
Building 09—Photo #66: East extension from main building. Damaged masonry.

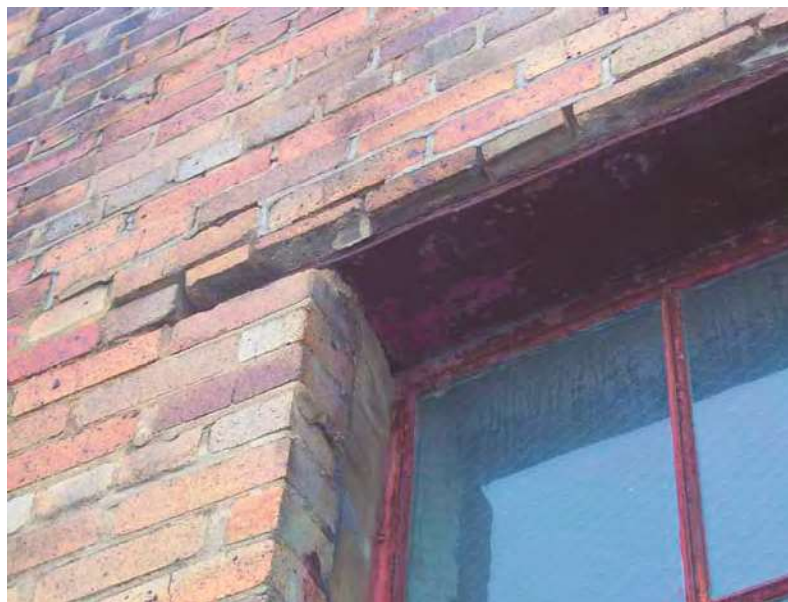
Building 09—Photo #67: Window at single story extension, rusted window lintel and damaged masonry.

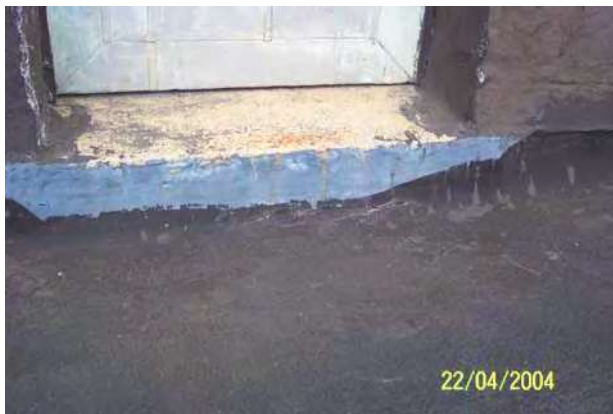
Building 01—Roof Photo #3: Observed deterioration of flashing at door sill. Recommend re-flashing.

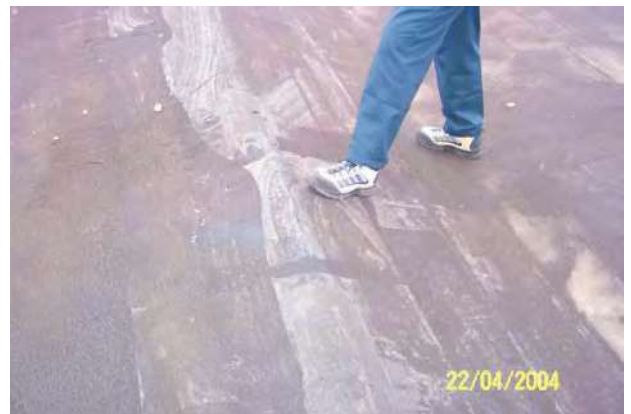
Building 01—Roof Photo #4: Exposed fibers of roofing membrane. Recommend repair or replacement.

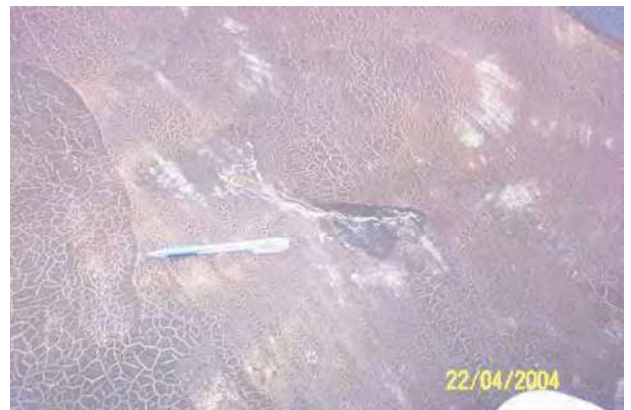
Building 01—Roof Photo #7: Splitting membrane and deterioration of roof tar. Repair or replace roofing.

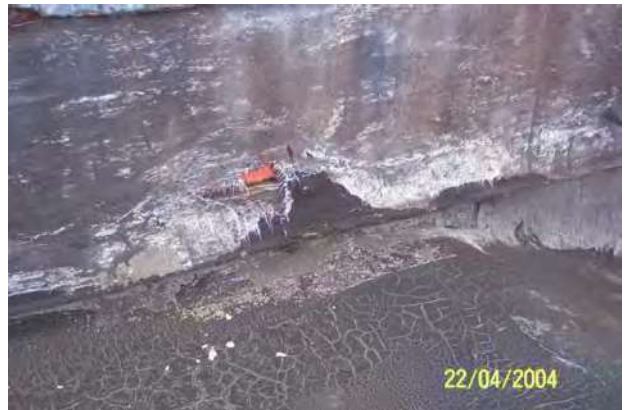
Building 01—Roof Photo #9: Observed deteriorated parapet flashing. Repair or replace required.

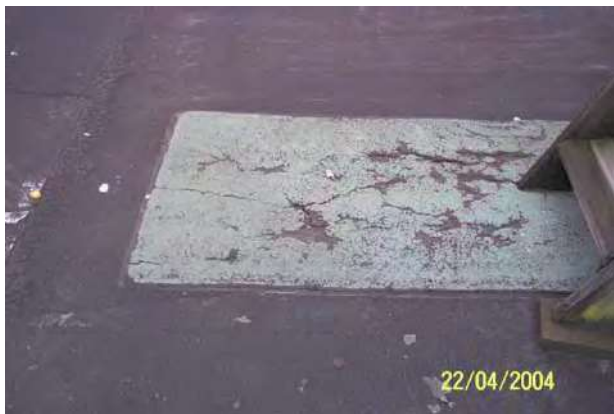
Building 01—Roof Photo #10: Abandoned and damaged equipment pad.

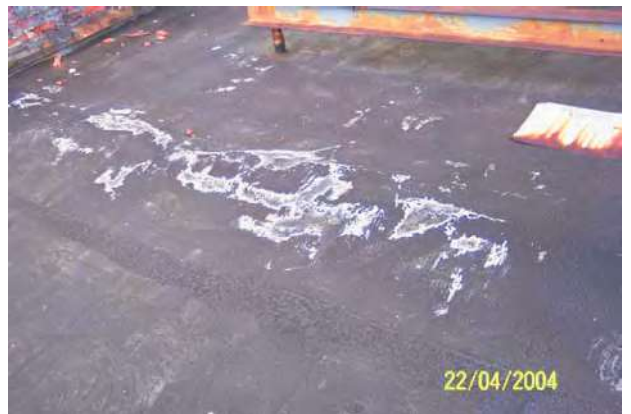
Building 01—Roof Photo #11: Exposed roof membrane.

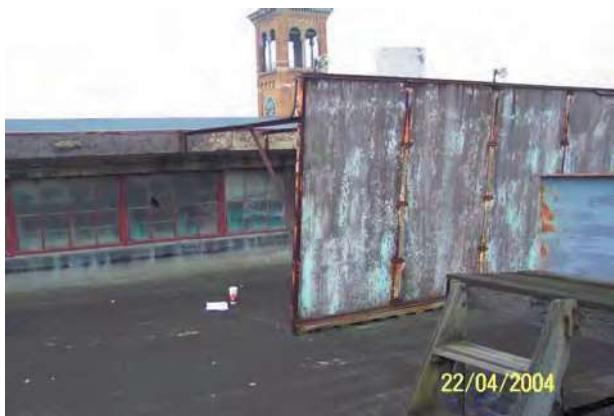
Building 01—Roof Photo #14: Abandoned wood structure. Recommend removal, patch/ repair roofing.

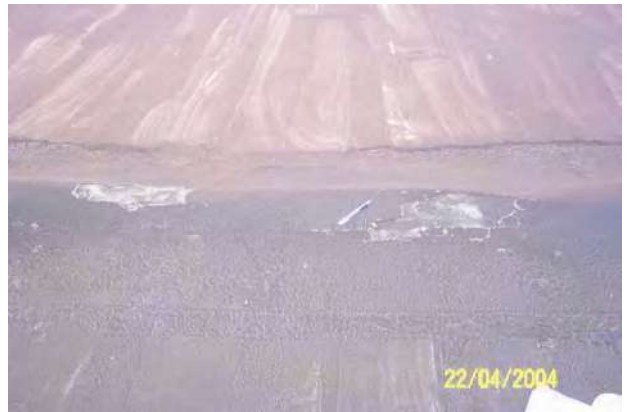
Building 01—Roof Photo #15; Cracked roofing membrane. Patch or replace.

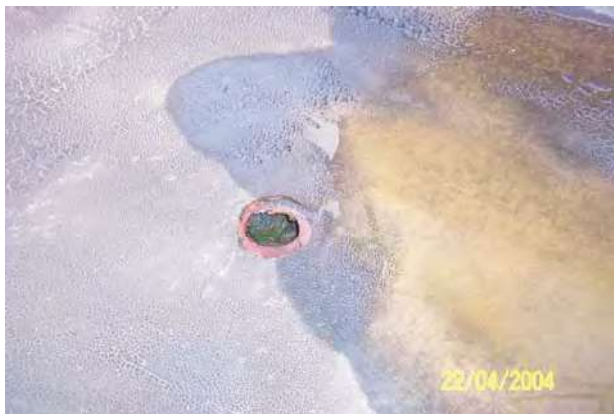
Building 01—Roof Photo #16: Abandoned rooftop equipment stanton. Remove to below roofing. Patch roofing membrane.

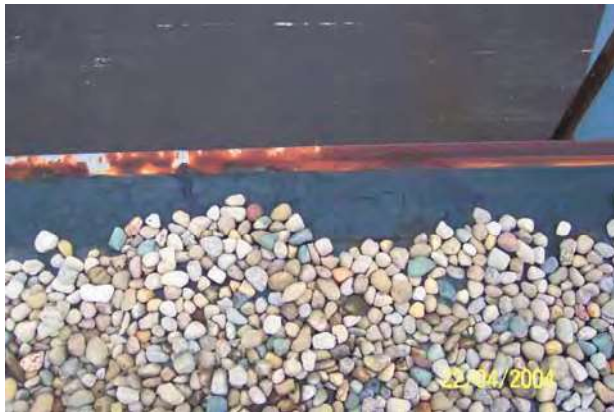
Building 01—Roof Photo #20: Clerestory roof. Milflashing is deteriorated. Repair or replace.

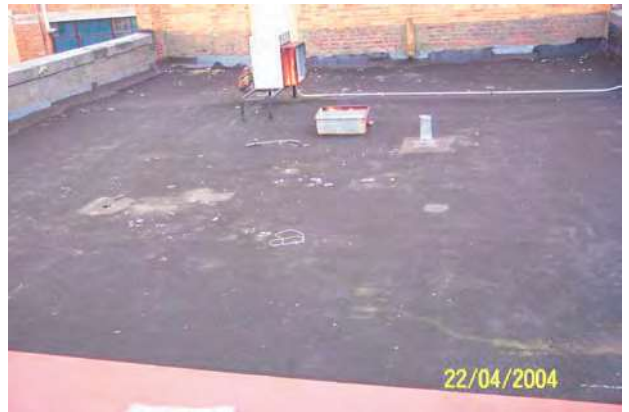
Roof Photo #2: Connector between Building 01 and Building 03. No grate screen on roof drain.

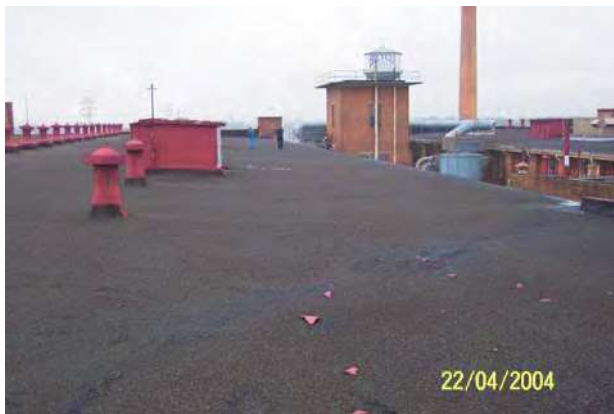
Building 03—Roof Photo #22: Built up roofing, broken clay tile roofing. Presumably from clock tower roof. Clock tower roof was not accessible. Evidence missing the roofing was visible.

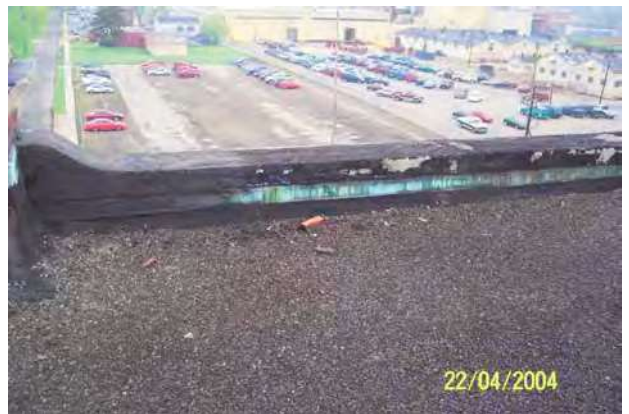
Building 02—Roof Photo #23: Roofing tar on stone coping, milflashing under stone.

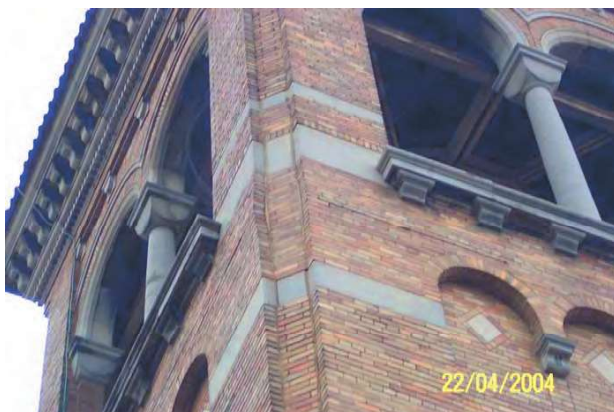
Building 02—Roof Photo #24: Clock tower. Observed evidence that roofing tile has slipped from roof. Repair should be high priority, considering liability to visitors at main entrance.

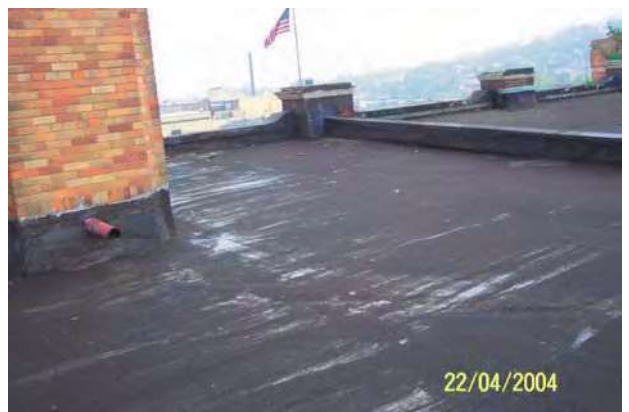
Building 02—Roof Photo #25: Worn roof membrane at base of clock tower. Repair or replace.

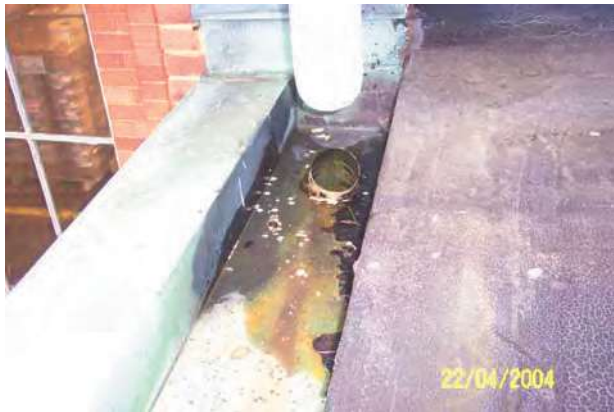
Building 04—Roof Photo #26: Gutter drain. Screen should be installed.

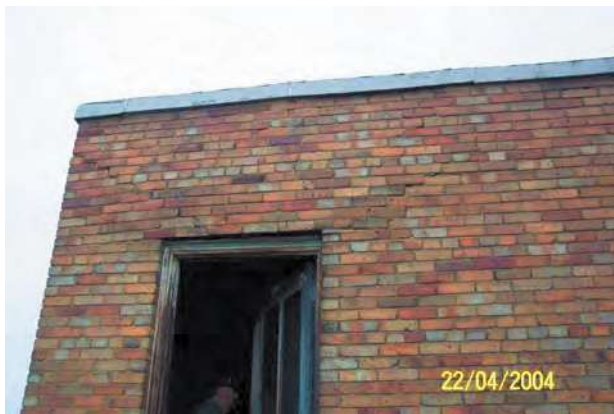
Building 04—Roof Photo #28: Evidence of movement in masonry at window head. Repair required to maintain masonry.

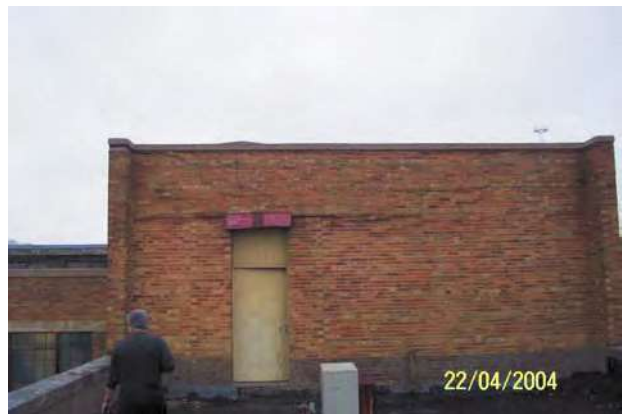
Roof Photo #29: Connector between Building 01 and 02. Observed evidence of movement and cracking of masonry. Repair is required.

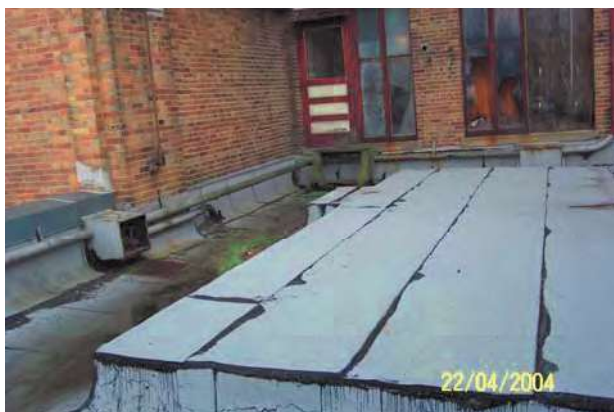
Building 07—Roof Photo #30: Observed standing water on lower roof. Growth of moss indicates long term problem. Note broken glass in windows beyond.

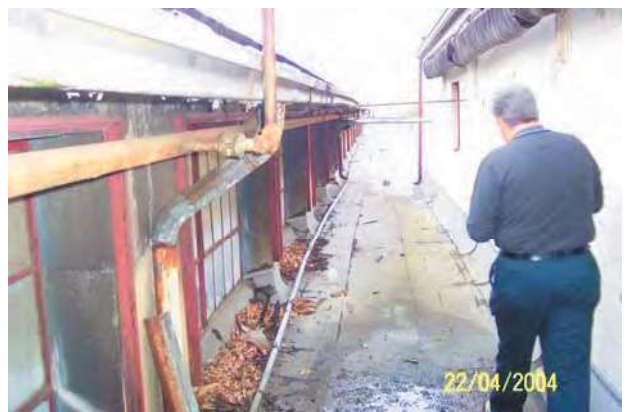
Building 07—Roof Photo #31: Single story clerestory windows. Observed damaged gutter. Downspouts require repair. Debris should be removed from roof as part of yearly maintenance.

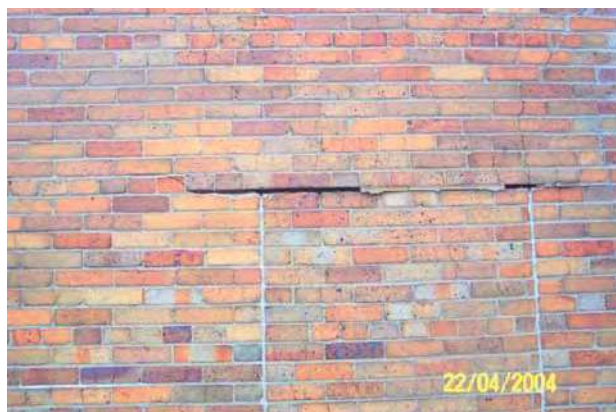
Building 07—Roof Photo #32: Evidence of movement in masonry, possibly old opening bricked in. Repair sealant at lintel, tuck point masonry.

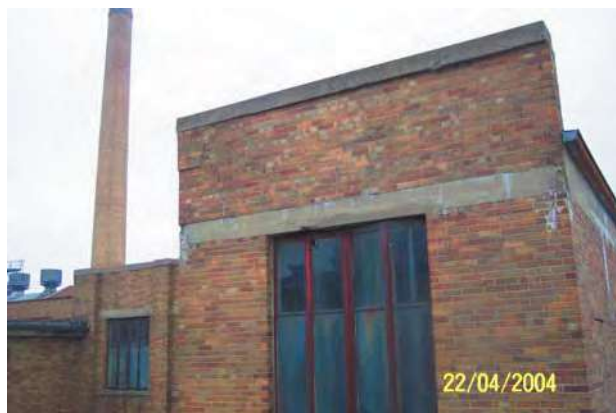
Building 07—Roof Photo #34: Observed evidence of movement of masonry at parapet coping stone. Repair is required.

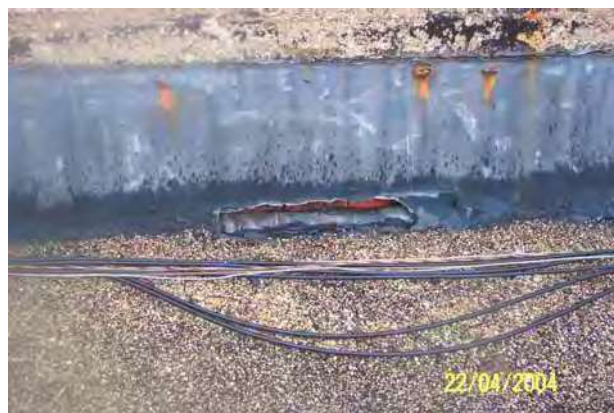
Connector between Building 04 and 06—Roof Photo #35: Observed damaged flashing at junction of parapet and roof. Repair required.

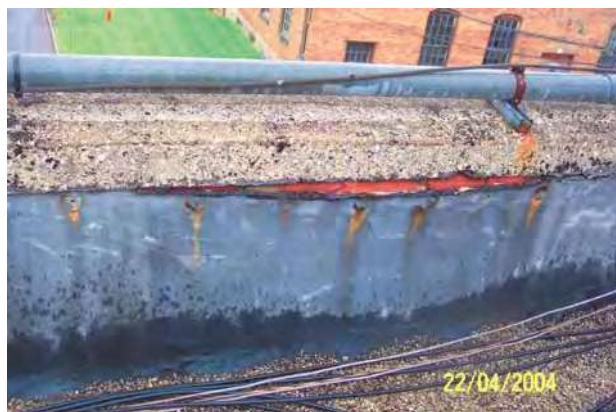
Connector between Building 04 and 06—Roof Photo #36: Observed parapet flashing damage. Repair required.

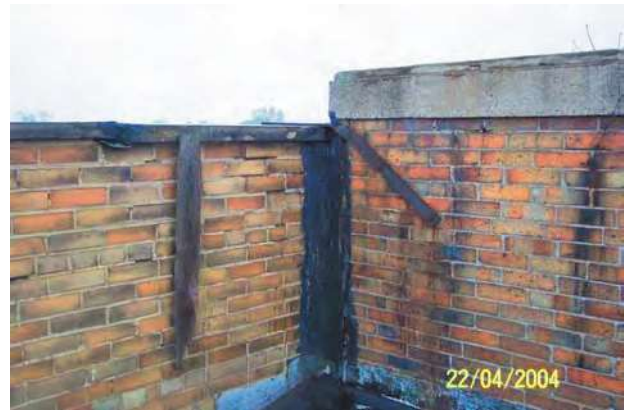
Building 06—Roof Photo #39: Observed existing roofing mastic patch at intersection of parapet. Replace patch. Tuck point masonry.

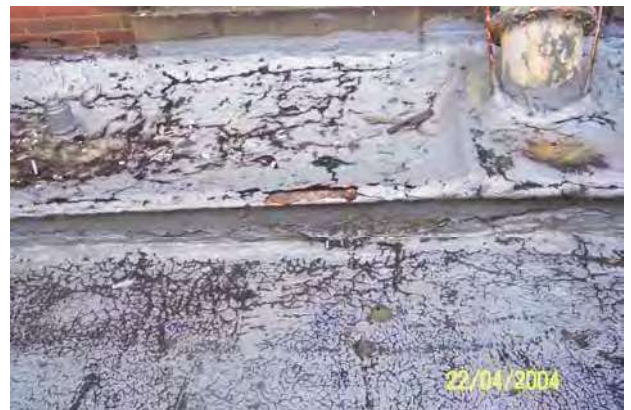
Building 05—Roof Photo #44: Observed multiple layers of roofing mastic. Recommend removal and replacement of old roof.
